Surface Stratigraphy on Limestone of Venetian Palaces

*Manuela Sgobbi, Peter Brimblecombe, Carlota Grossi,
Guido Biscontin, Elisabetta Zendri*

Abstract

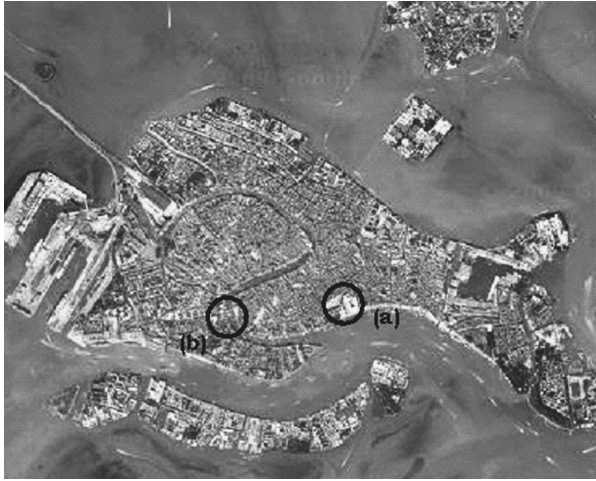
Figure 1 The city of Venice seen from satellite showing the location of (a) San Marco Square and (b) Palazzo Rezzonico.

The outer layers of stone were sampled from three Venetian palaces: Libreria Marciana, Procuratie Nuove and Palazzo Rezzonico (Figure 1). These three buildings can be considered representative of the city notably as public buildings (Marciana Library), a chamber of government of the Venetian Republic (Procuratie Nuove) and a private house (Palazzo Rezzonico or Ca’ Rezzonico). The palaces are all built in Istrian stone, a limestone originating from quarries belonging to the Venetian government in the Istria region of the Balkans. The stone was used because of its well-known resistance to the severe climate of the lagoon.

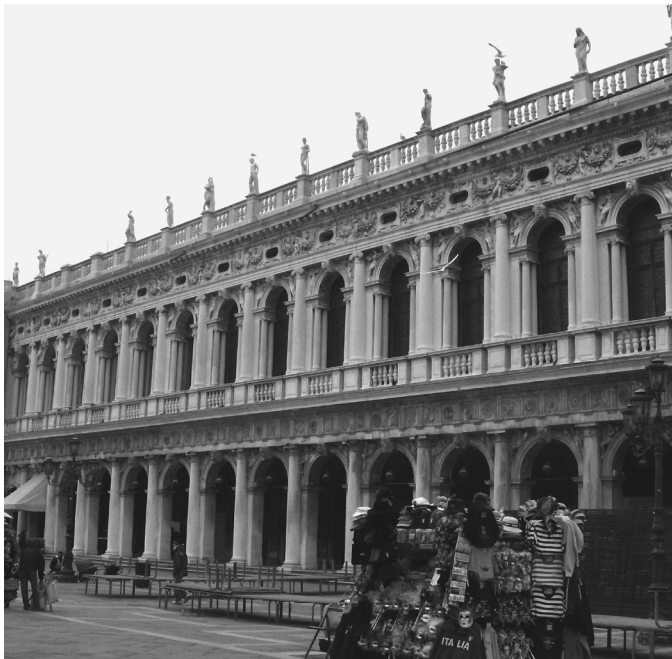
Figure 2
Libreria
Marciana, San
Marco Square,
Venice.

The Libreria Marciana (Figure 2) was built between 1537 and 1588. It was started by Jacopo Sansovino and completed by Vincenzo Scamozzi along

the lines proposed by Sansovino. To protect the stone surface, especially the sculpture, Sansovino used a special mixture reported in ‘Secreti Diversi’ (a manuscript conserved in the Libreria Marciana and known as the ‘Marciana’ manuscript).²³ The mixture was composed of sandarac, nut oil, incense resin and alum. The library was restored during the following centuries using a different treatment from that adopted by Sansovino. The Bell Tower collapsed in 1902, destroying the corner of the library. This was repaired and treated, but our samples are from an undestroyed part of the building.

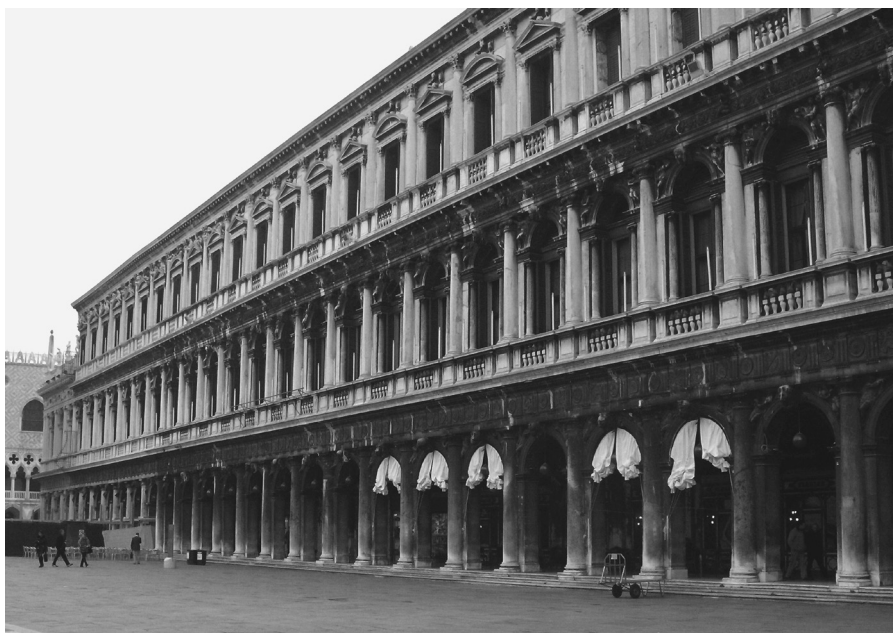
Figure 3 Procuratie Nuove, San Marco Square, Venice.

The construction of houses for the Procuratori di San Marco (magistracy of the Republic of Venice) began in 1586 with Vincenzo Scamozzi and was finished in 1640 by Baldassarre Longhena. The building (Figure 3) underwent continual maintenance and restorations during the nineteenth century, so the appearance of the façade (recorded in archive pictures) remained unchanged for at least two centuries. When these continuous works were halted between the First and Second World Wars, the front of the palace showed immediate signs of decay.

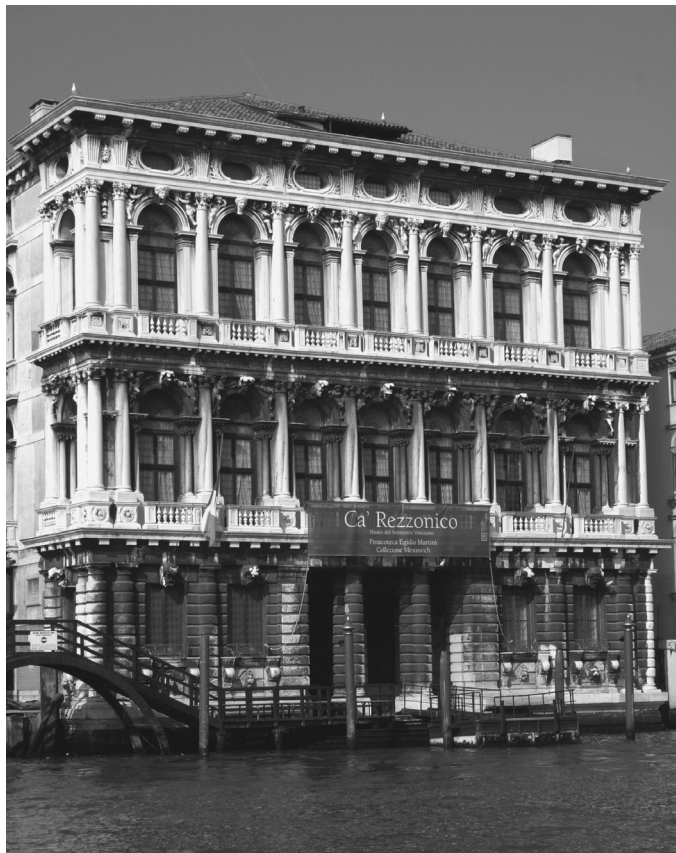
Figure 4 Ca' Rezzonico, Canal Grande, Venice.

Palazzo Rezzonico or Ca' Rezzonico (Figure 4) was started in 1649 by Baldassarre Longhena and completed in 1756. The palace was restored several times, particularly during the twentieth century. The latest restoration (1986) involved the removal of most of the nineteenth-century wax-based treatments.

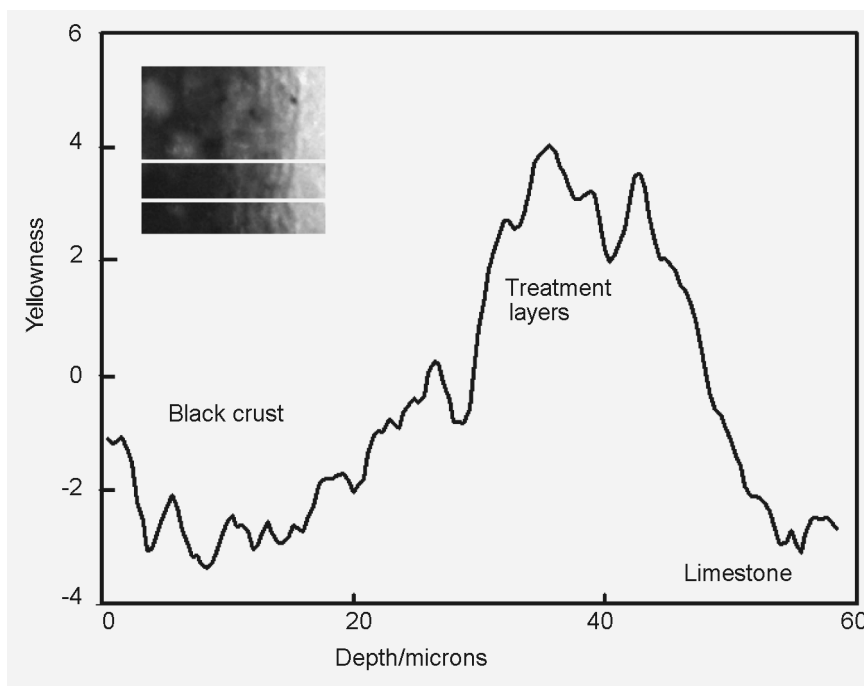
Figure 11 A profile of yellowness through sample cr10_1 from Ca' Rezzonico (each point in the profile represents an average from 30 scans). The inset shows a monochrome micrograph from the cross-section. The area averaged to obtain the profile lies between the two white horizontal lines. The inset also shows fine-scale stratification within the wax layer.

Colour was determined by an analysis of the RGB values in digital photomicrographs. The RGB values showed the wax layers to be more yellowish. These layers lie between the two white horizontal lines marked in the inset, which shows a small cross-section of a sample from Ca' Rezzonico. By averaging reduced noise and by using the RGB values of the pixels, it was possible to determine a profile of yellowness as presented in Figure 11. This shows that the wax is more yellow than the black crust or the white limestone. The monochrome inset also shows the stratification that arises from brush strokes during application of the treatment layer.
